TRAFFIC FEASIBILITY STUDY

Route 28 (South Orleans Road)/Route 39 (Harwich Road)/Quanset Road Intersection

Orleans, Massachusetts

Fay, Spofford & Thorndike, LLC
146 Main Street-Unit 3
Hyannis, Massachusetts 02601

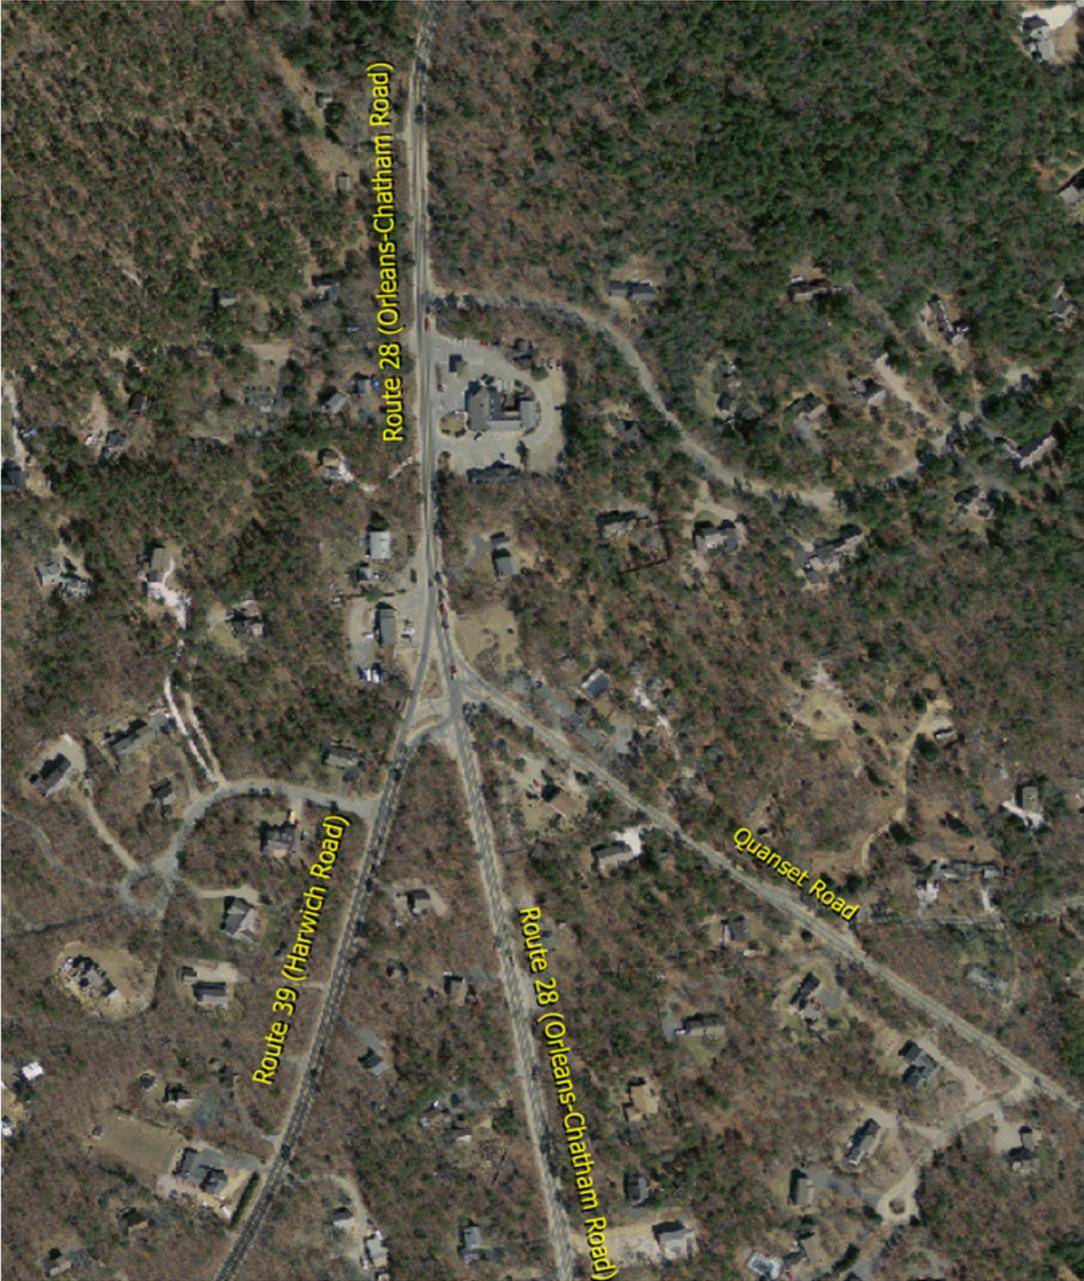
Fay, Spofford & Thorndike (FST) is assisting the Town of Orleans with the preliminary planning for improvements to the Route 28 (South Orleans Road)/Route 39 (Harwich Road)/Quanset Road intersection. The study area intersection is shown in Figure 1 below.

Figure 1 –Study Area Intersection

This 4-way unsignalized intersection serves as one of the primary access points from the south on Route 28 to Orleans Center. Land use at the intersection consists of town property (former old school house site) in the northeast quadrant, American Heritage Realty headquarters on the northwest side, residential property on the southeast and west quadrants and Ridgewood Motel and cottages on Quanset Road to the east.

Route 28 (South Orleans Road), is intersected from the southwest by Route 39 (Harwich Road) and Quanset Road from the east to form a skew-angle unsignalized intersection in South Orleans. Route 28 runs north/south,¹ is owned and maintained by MassDOT and is functionally classified as a principal arterial. Route 39 (Harwich Road) is a Town-owned roadway and is classified as a rural minor arterial while Quanset Road is also owned by the Town and is classified as a local road. The minor approaches are offset from each other creating awkward turning movements to/from the side streets approaches. This intersection is under MassDOT jurisdiction.

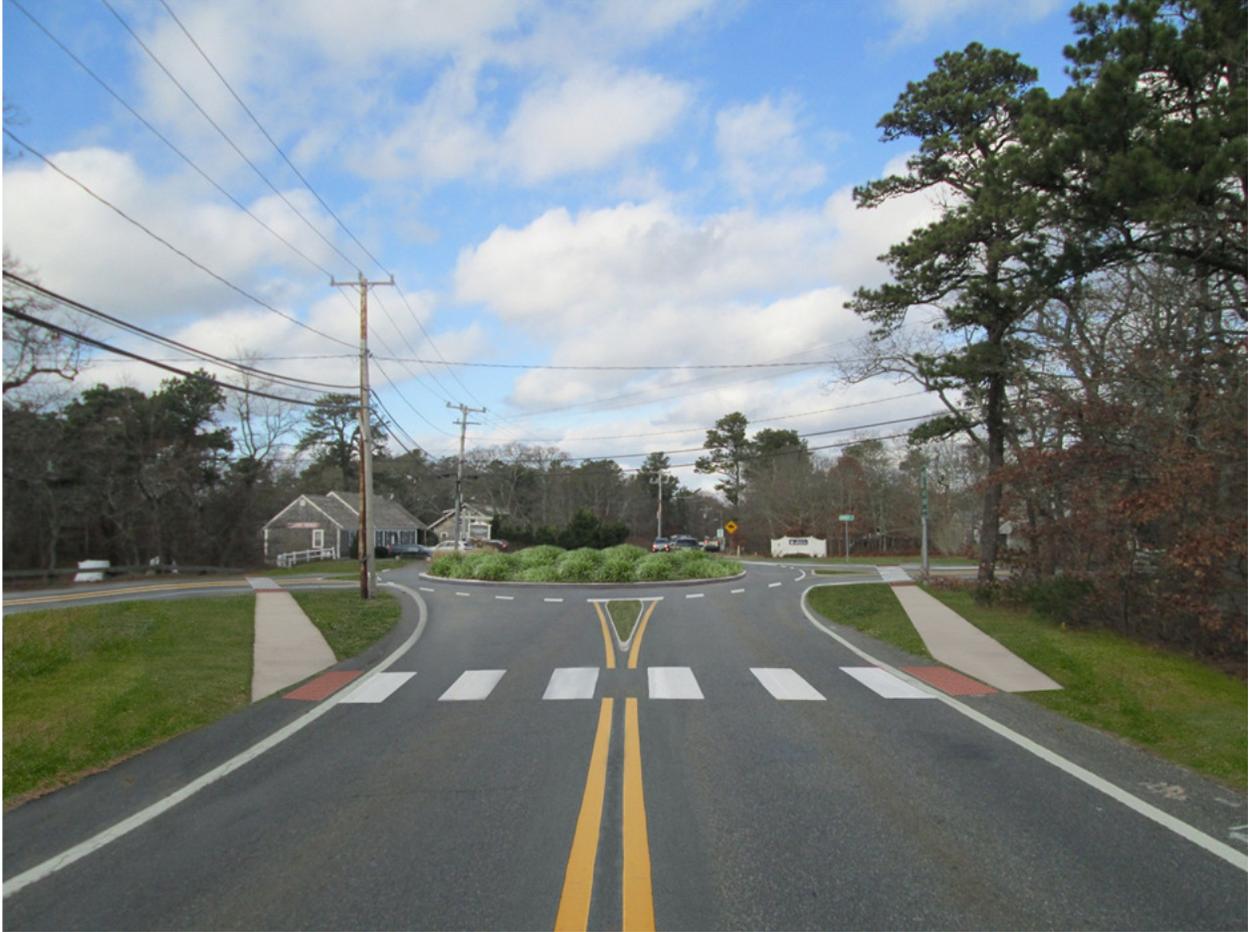
Figure 2 – Alternative 1 - Roundabout

One alternative for improvement at the intersection is to construct a round-about to control turns and improve operations. A roundabout has recently been constructed in the Town at the Route 28/6A intersection in a more densely-populated and constrained area, so installing one on the south end of Town would provide another gateway to the Town. Advantages at this location would include, reduce speeds in the area, a better mechanism for controlling turns at two designated State routes, minimal or no land takings and minimal roadway maintenance to maintain this traffic control device. A street view picture of the intersection as it exists today is shown in Figure 1 (before condition); while a photo simulation of the intersection with the roundabout in place (after condition) is shown in Figure 2.

Based on the review of expected traffic operations, minimal right-of-way impacts and limited long-term maintenance, the roundabout alternative is recommended to be pursued. With an existing roundabout at Route 28/Route 28 in north Orleans that serves as a gateway from the north in the busiest location in-Town, this South Orleans location will serve as the southern gateway to Town. As currently proposed, this roundabout will have single lane approaches on Route 28, Route 39 and Quanset Road and provide for both pedestrians and bicycles.

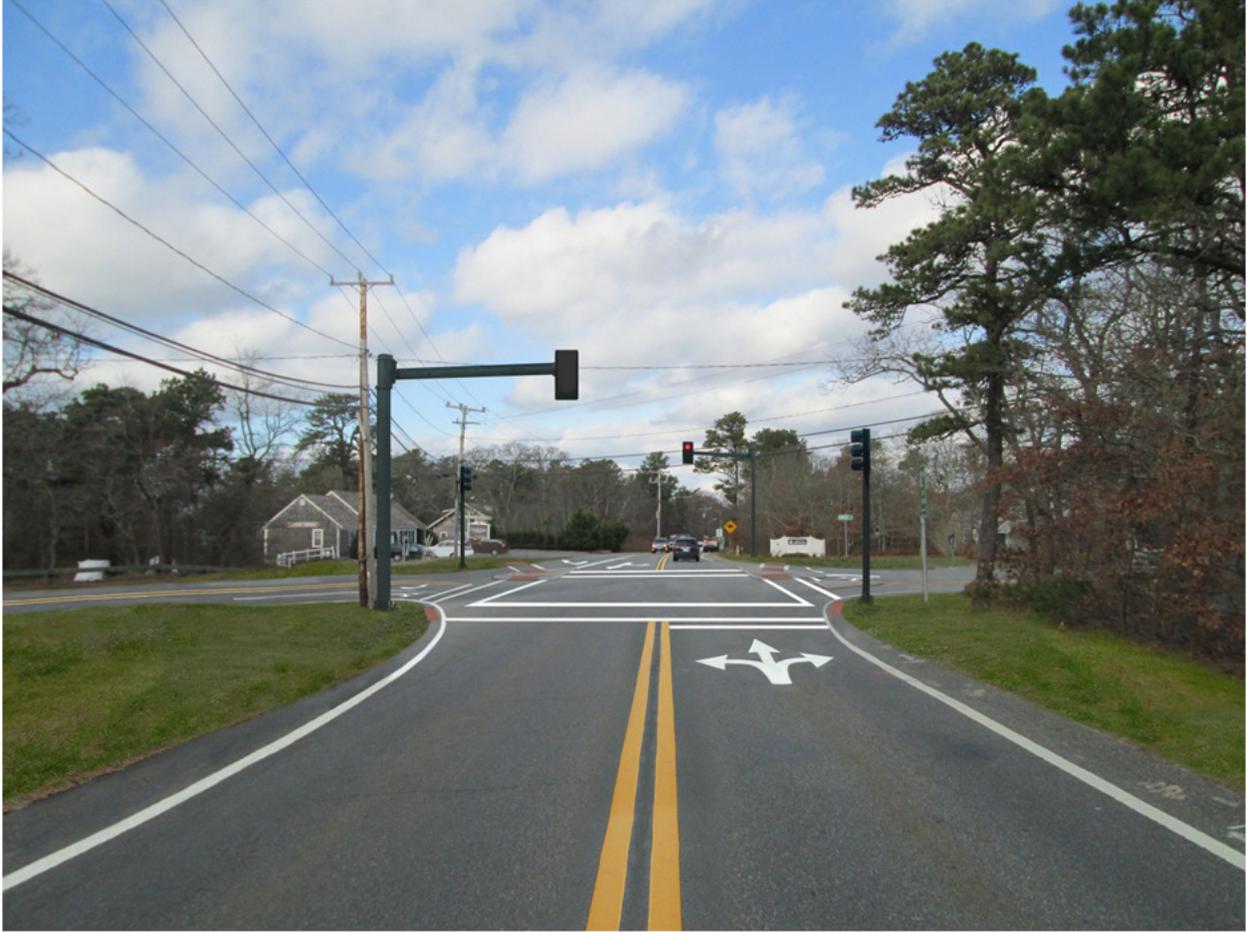
Figure 3 – Alternative 2 – Signalized

Another alternative for intersection improvement would be to install a traffic signal and re-design the geometry. A signal would provide a controlled mechanism for all traffic movements and reduce vehicle delays that presently exist on the side street approaches. New sidewalks would be added, and bicycle accommodation provided. Exclusive turn lanes could be provided for this improvement alternative. Preliminary review of traffic signal warrants in the *Manual on Uniform Traffic Control Devices*³, indicate that the intersection meets peak hour warrants. Capacity analysis was conducted of the signalized alternative and for a multi-phase signal the intersection would operate at level of service A (LOS A) for both peak periods. A photo simulation of this intersection upgrade is shown in Figure 3.
